# Manhole Inspection Summary

Manhole # S29A\_\_027MH

Insp Date: **11/6/07 9:50 AM**

**Location** Address: **909 MYRTLE AVE**

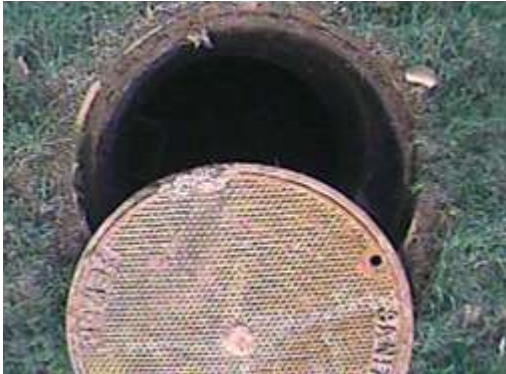
Defect 1

**Frame** Offset: **4** (in.) Condition: ☒ Sound ☐ Cracked ☐ Leaks

FRAME OFFSET

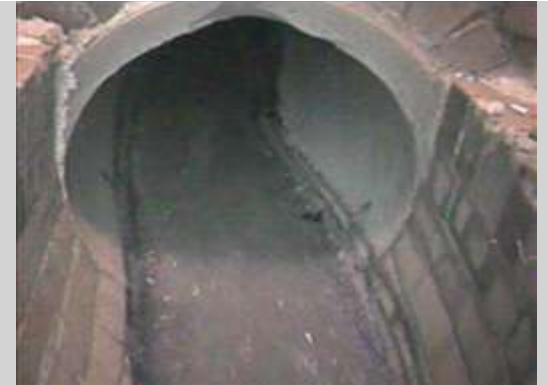
12 O'Clock Outflow

18 in. Circular Gravity Sewer  
Pipe Out @ 12 O'Clock

Pipe Height: **14.4** (in.) Rod and Bar  
Pipe Material: **Clay** ☐ Pipe Lined  
Invert Depth: **13.38** (ft.) Flow Characteristics: **Slow**  
Deposits: ☒ None ☐ Mud ☐ Sludge ☐ Debris ☐ Grease  
Silt Depth: (in.) Deposits Extent:  
Infiltration: **None** Pipe Seal Cond: **Sound**

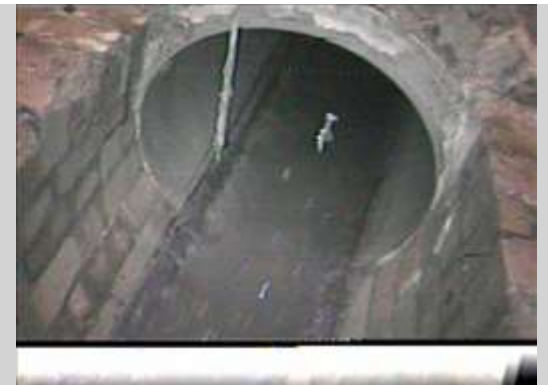
6 O'Clock Inflow

18 in. Circular Gravity Sewer  
Pipe In @ 6 O'Clock

Pipe Height: (in.) Direct  
Pipe Material: **Clay** ☐ Pipe Lined  
Invert Depth: **13.35** (ft.) Flow Characteristics: **Slow**  
Deposits: ☒ None ☐ Mud ☐ Sludge ☐ Debris ☐ Grease  
Silt Depth: (in.) Deposits Extent:  
Infiltration: **None** Pipe Seal Cond: **Sound**
